**ANDOVER ROD
AND GUN CLUB DAM
ALLEGANY COUNTY, NEW YORK
INVENTORY NUMBER NY 439**

**PHASE 1
INSPECTION REPORT
NATIONAL DAM
SAFETY PROGRAM**

**L. ROBERT KIMBALL and ASSOCIATES
615 W. Highland Ave. Ebensburg, Pa.**

Date of Inspection: August 31, 1978

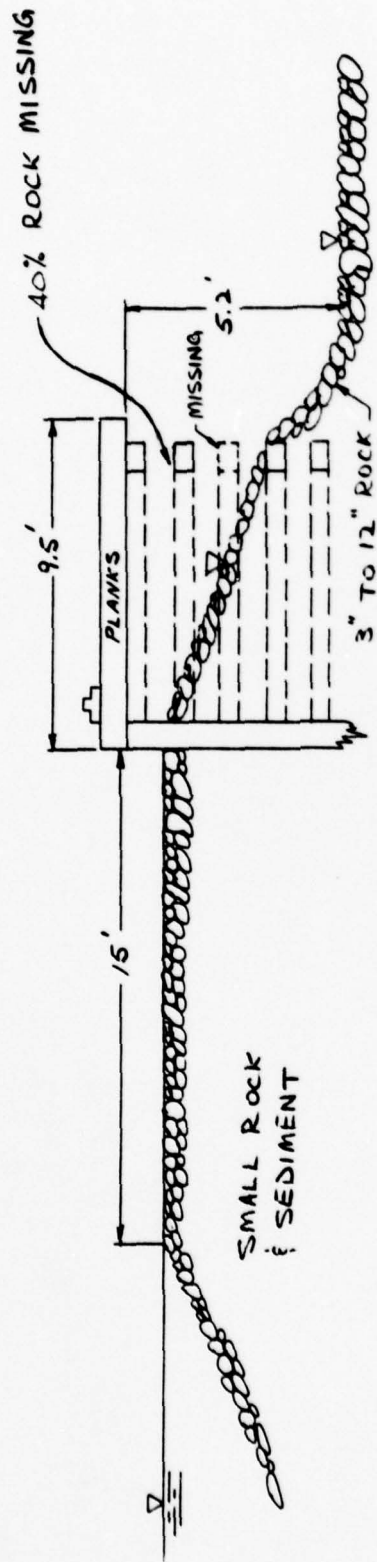
MAXIMUM SECTION
LEAKAGE SECTION
SCALE: 1" = 5'

- a. General: The Andover Rod and Gun Club Dam was inspected by L. Robert Kimball and Associates personnel on August 31, 1978 accompanied by Howard Burdick, supervisor of the Town of Andover.
- b. Dam: Visual inspection revealed a large hole in the center portion of the timber crib section. The upstream planking was broken and missing and one of the downstream cross ties was absent. Approximately 40 percent of the rockfill was removed. All discharge (estimated at .75 cfs or 337 gal/min) was through this portion of the dam (See cross section Appendix E).
